## DECISION MEMORANDUM

**SUBJECT: IN THE MATTER OF THE INVESTIGATION OF ATLANTA POWER  
COMPANY SERVICE AND CUSTOMER RELATIONS;  
STAFF SAFETY REPORT; CASE NO. ATL- E-18-01**

**STAFF SAFETY REPORT  
APRIL 16, 2018**

**RICHARD KELLER, P.E.  
IDAHO PUBLIC UTILITIES COMMISSION**

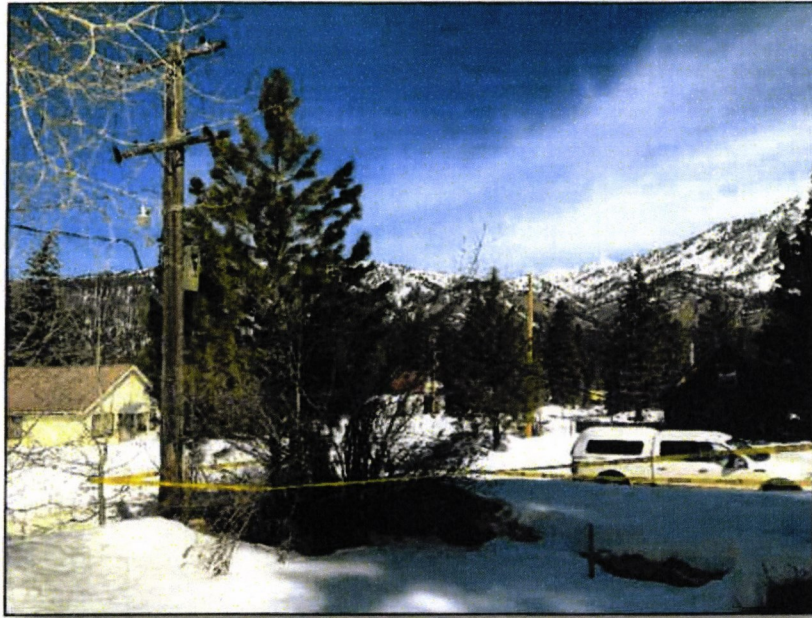
*Figure 2 - West Support Pole*

Staff noted the pole attachment hardware on the west pole was hanging from the service wire, and was likely pulled out of the pole when the snow slid from the roof. All wire connections to the service line were still intact. Staff requested additional barrier tape to be placed on the south side of the downed line to better restrict access to the area.

Staff recommends the downed service line be repaired as soon as possible. Furthermore, Staff recommends the Company immediately address the safety issues concerning the turbine-generator pulley as it poses an immediate safety hazard to personnel and equipment within the powerhouse.

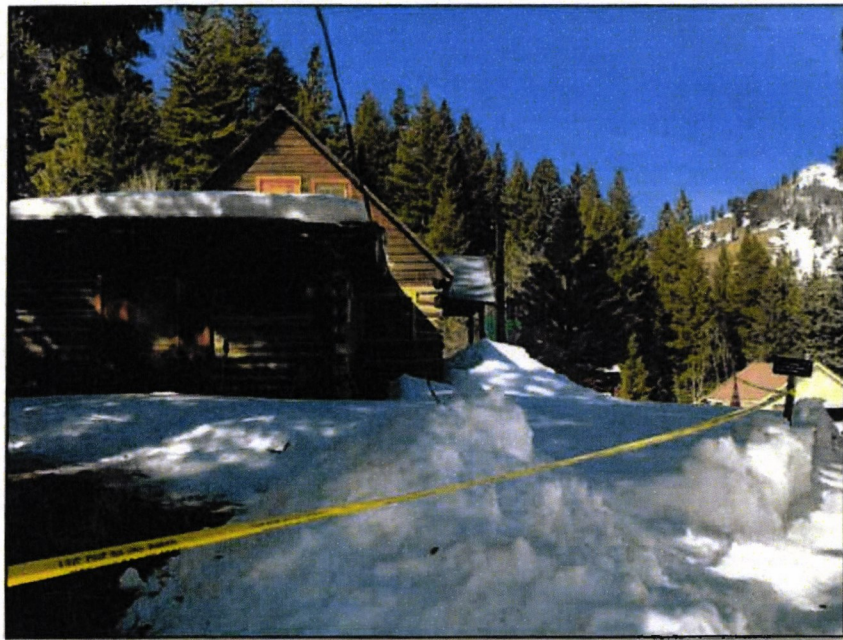
*Figure 3 - Looking West*

Sandra Nye, the customer receiving power from the downed service line, indicated her power was still on, and that no arcing or shorting of the service has been experienced. She indicated the service line spanning between the two poles was near the edge of the neighbor's roofline and that snow sliding off the roof pulled the line to the ground.

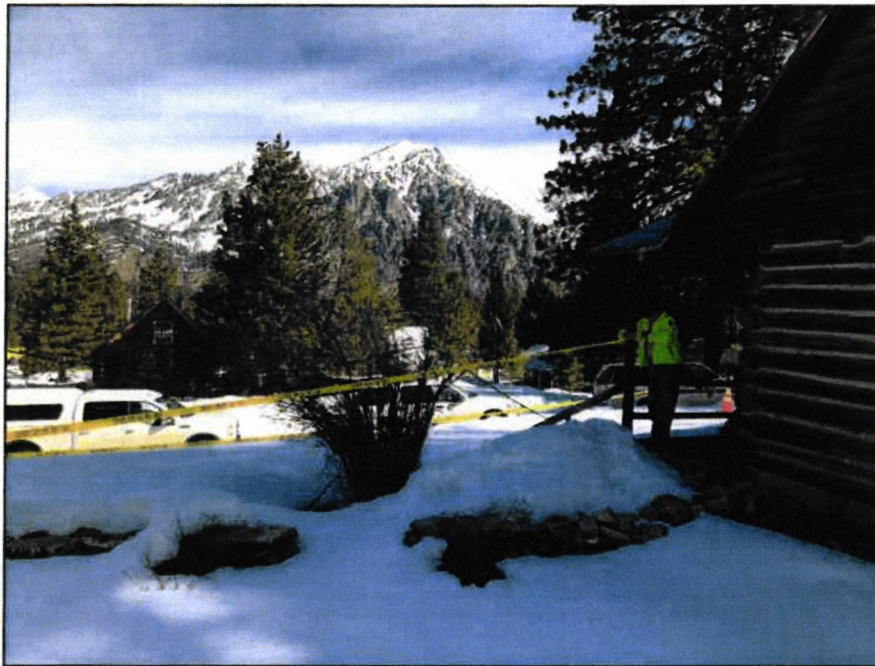
*Figure 2 - Looking North - Requested Barrier Tape*

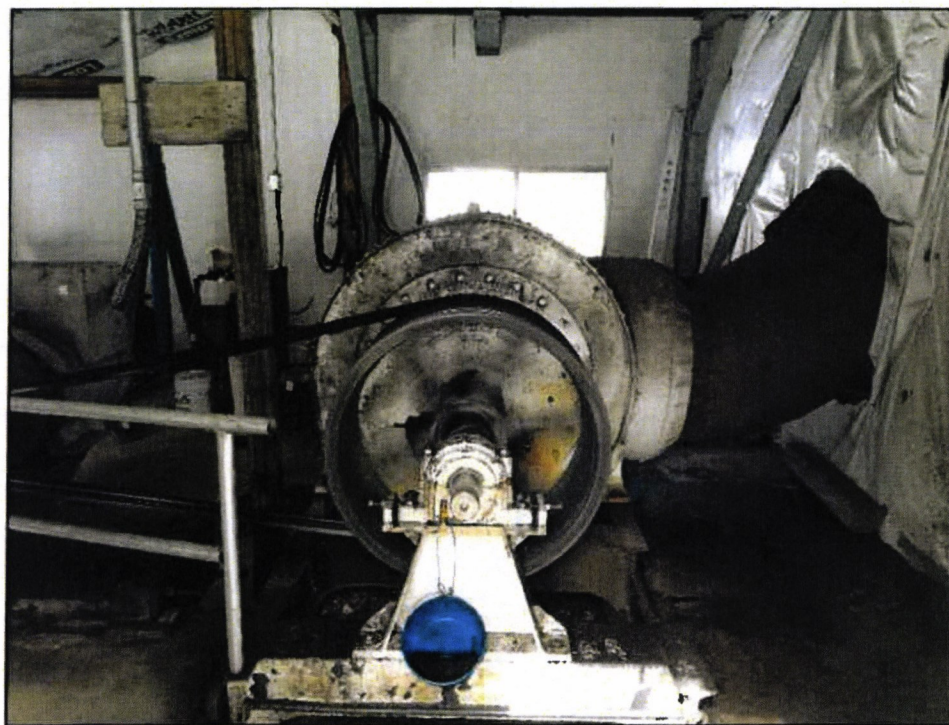
*Figure 3 Turbine Drive Pulley and Belt*

The Fire Chief identified major components at the dam site and provided a general description of equipment and its operation within the powerhouse. Upon inspection, one

serious concern identified by Staff is the inadequate protection found around the drive pulleys and belts of turbine-generator within the powerhouse. Although there is a makeshift railing separating building access from the turbine-generator drive itself, Staff believes the barrier is inadequate and that it provides minimal safety protection for any personnel entering the powerhouse building. OSHA requirements indicate the turbine-generator drive itself would likely need to be fully enclosed for protection.
