CASE NO. EAG-W-00-1

**STAFF INVESTIGATION OF
EAGLE WATER COMPANY
AND ITS ABILITY TO PROVIDE
ADEQUATE WATER SERVICE
TO THE CUSTOMERS OF
EAGLE SPRINGS ESTATES SUBDIVISION
AND ADJACENT CERTIFICATED AREAS**

**Report of the
Idaho Public Utilities Commission Staff**

August 22, 2000

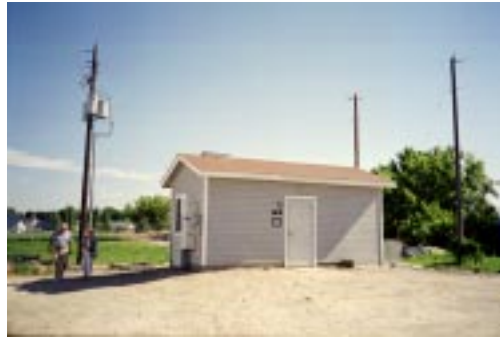
Figure 4. Well No. 4 pump.

On July 1 at 2:19 p.m. Eagle Water's Well No. 4 pump failed. Figure 4 shows the Well No. 4 pump house. Figure 5 shows the well pump. This failure caused a significant reduction in system pressure. Those customers most affected by the failure were those located at the highest elevations in Eagle Water's service area, and to a lesser extent, customers on the east side of Eagle Water's system who live in the vicinity of the pump. Because Eagle Springs Estates and Bonita Hills subdivisions are located at the highest elevations in Eagle Water's system, they were the areas most affected. The PUC Staff received 22 complaints. Figure 2 shows the locations from which the complaints originated. As shown by the figure, most of the complaints came from customers generally located in the highest

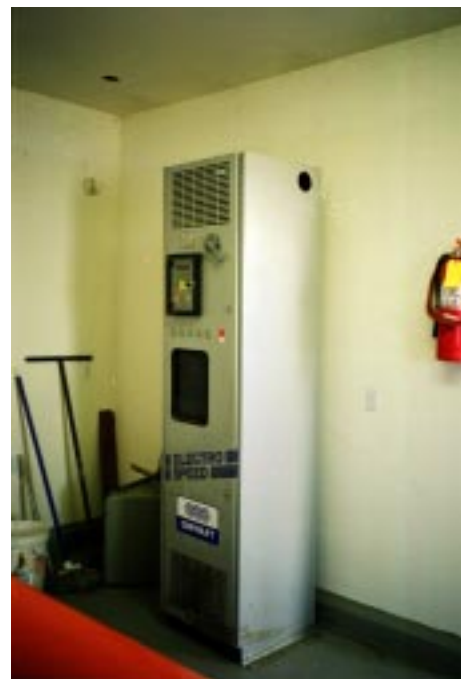
Figure 6. Exterior of the variable speed drive.

The initial failure of Well No. 4 was caused by burned out capacitors in the variable speed control unit of the well pump. Figure 6 shows the exterior of the

variable speed drive. The function of the drive unit is to change the frequency of the current going to the well pump. As the frequency is changed, the operating speed of the pump changes. The pump, in turn, delivers more or less water in order to maintain the desired pump discharge pressure. The capacitors that failed are large high-voltage

(480 volt) units, much different from the small electronic components that failed in the new controller. With burned out capacitors, the drive unit will not operate. Figure 7 shows the interior of the control unit. Figure 8 shows the burned out capacitors in more detail.

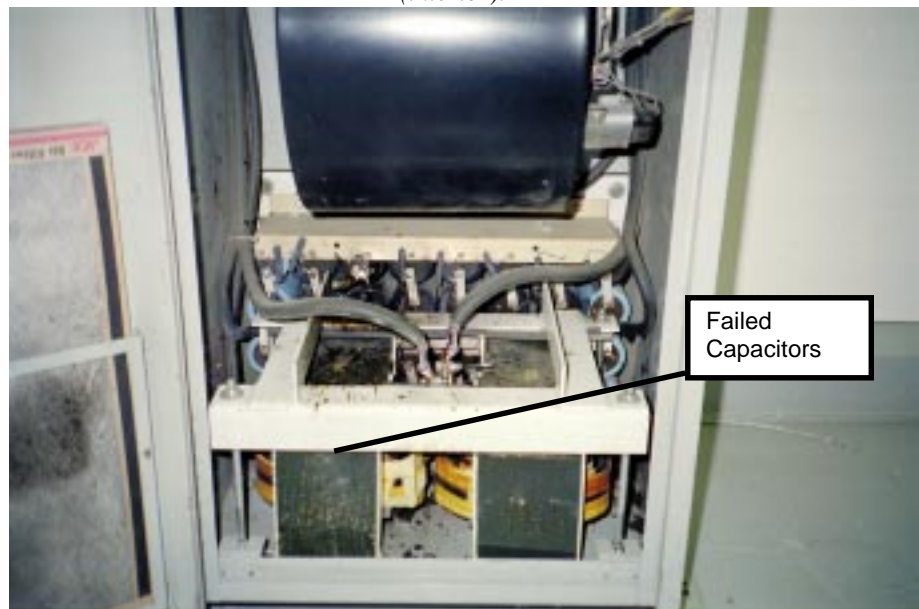
Figure 8. Well No. 4 variable speed controller capacitors.

The failed drive, manufactured by Centralift, was eventually returned to Riverside, Inc. of Parma, Idaho, the local manufacturer's representative. The drive was examined to determine the likely cause of the failure. This particular drive was equipped with the capability of recording and subsequently reporting an operating history. Consequently, the drive was repowered at the manufacturer's representative's shop and an operating history printed. The operating history report indicates that a voltage spike occurred at the time of the drive failure.

A voltage spike is a very rapid increase in voltage on the electric utility's system. They normally occur very infrequently, and can be caused by many different things. While the cause of the voltage spike is un-

known, it is certain that the cause cannot be attributed to Eagle Water. Well No. 4 is located in a small industrial park, and it is possible that one or a combination of industrial machinery starts or problems could have triggered the spike. The industrial park includes a machine shop, a book bindery, a body shop, a

cabinet shop, a boat motor repair shop, hardwood sales, and others. Extreme weather conditions are another possibility. At this point, there is really no way of knowing the exact cause.

1. The initial failure of the Well No. 4 pump was caused by the failure of the original variable speed drive unit. The failure of the variable speed drive unit, in turn, was caused by a voltage spike on Idaho Power's system. The failure cannot be attributed to Eagle Water.

The original failed drive unit, after being analyzed by the manufacturer's representative, can be repaired. Repairs are estimated to cost about \$2500. Eagle Water has not yet decided whether to proceed with repairs. If they do decide to repair the unit, it could be returned to service at either Well No. 4 or possibly at the new well planned to be completed this winter.

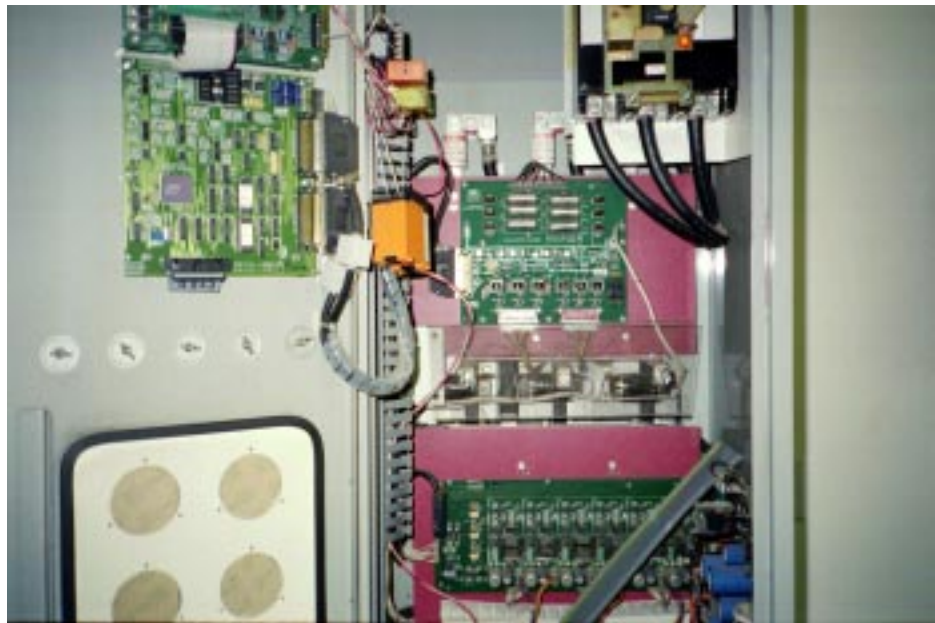
Figure 9. Well No. 4 variable speed controller electronics.

Electric, the manufacturer's representative. It was determined that the cause of the failure of the replacement drive was the failure of two capacitors located inside the 24-volt electronic part of the drive unit. These capacitors are small, simple electronic components, each about the size of a bean. Figure 9 shows some of the electronics inside a variable speed drive unit.

Initially, the manufacturer attributed the failure of the electronic components to manufacturing defects. However, further investigation is being done to determine whether a voltage surge could have also caused this failure. In this particular controller, protective devices are incorporated to prevent damage to sensitive components caused by power quality problems. In either case, the failure was not caused by anything Eagle Water did or did not do.

2. The second failure of the Well No. 4 pump was caused by the failure of electronic components in the new replacement variable speed drive unit. The manufacturer of the unit admits that the problem was manufacturing defects, and not attributable to Eagle Water.

Because the failed parts were integral parts of a larger circuit board, an entire replacement board had to be ordered. The replacement board was ordered from Danfoss, the manufacturer in Chicago. The part was shipped immediately by overnight mail. The replacement part was received and installed on July 7. The pump was returned to service at approximately 12:30 a.m. on July 7. The replacement variable speed drive unit has operated normally since it was returned to service.

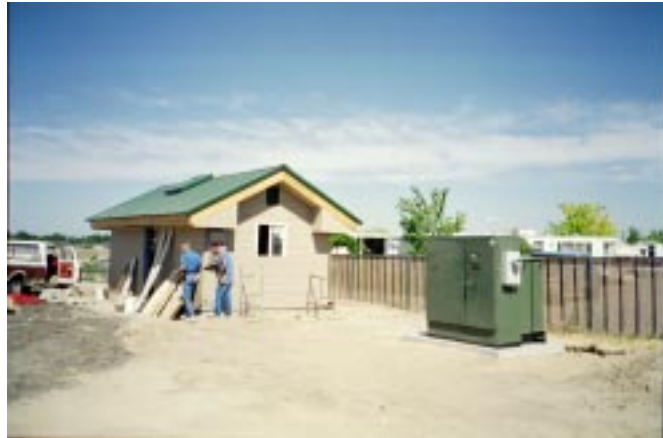
Figure 10. New booster pump house under construction.

After Well No. 4 failed, Eagle Water stepped up its efforts to complete the installation of the new booster pump. Idaho Power was requested to instruct its contract line extension crew to expedite the line extension work. Electricians were

called in to complete wiring inside the pump house. A variable speed drive unit for the booster pump had previously been ordered, and installation commenced soon after the outage. Figure 10 shows the pump house for the new booster under construction on July 11.

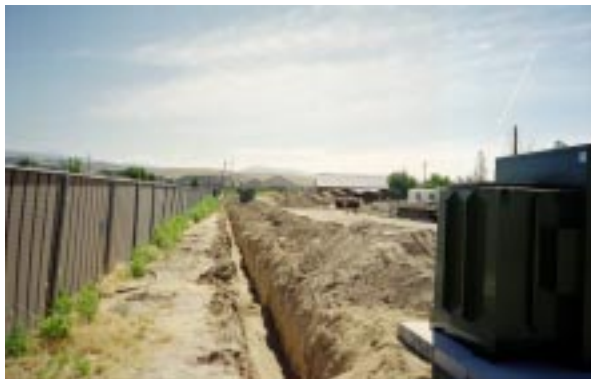
Figure 11. Underground electrical line extension to new booster pump house.

Idaho Power contract crews completed the line extension work on July 10. Figure 11 shows the underground line extension to the new

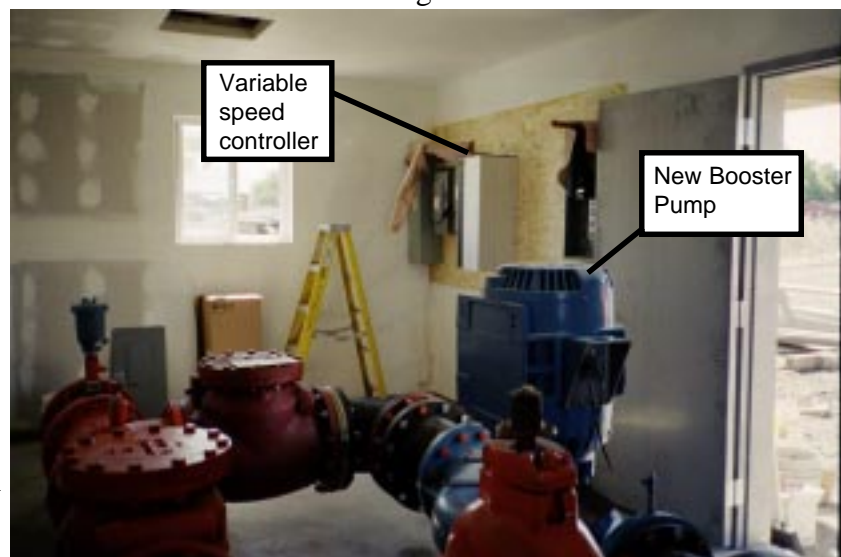
Figure 12. New booster pump during final installation.

boosted station. Electricians hired by Eagle Water completed wiring of the pump house and the variable speed drive controller on the following day. The new booster pump was put on-line at approximately 2:00 p.m. on July 11. Figure 12 shows the new booster pump during final installation.

Before the pump was started, pressure at the pump house was 63 psi. After the pump was started, pressure at the pump house immediately increased. The variable speed drive manufacturer's representative, who also was responsible for supplying the booster pump, programmed the drive and adjusted it to operate properly. Today, during normal operation at full speed, intake pressure at the booster is about 60 psi. Outlet pressure is about 93 psi. Since the pump was installed, Eagle Water has experienced no problems. The booster pump has operated continuously since first going online on July 11.

5. Staff recommends that Eagle Water investigate the possibility of modifying the new booster pump to provide greater flow and/or pressure. It may be possible that minor pump impeller trimming could improve performance.

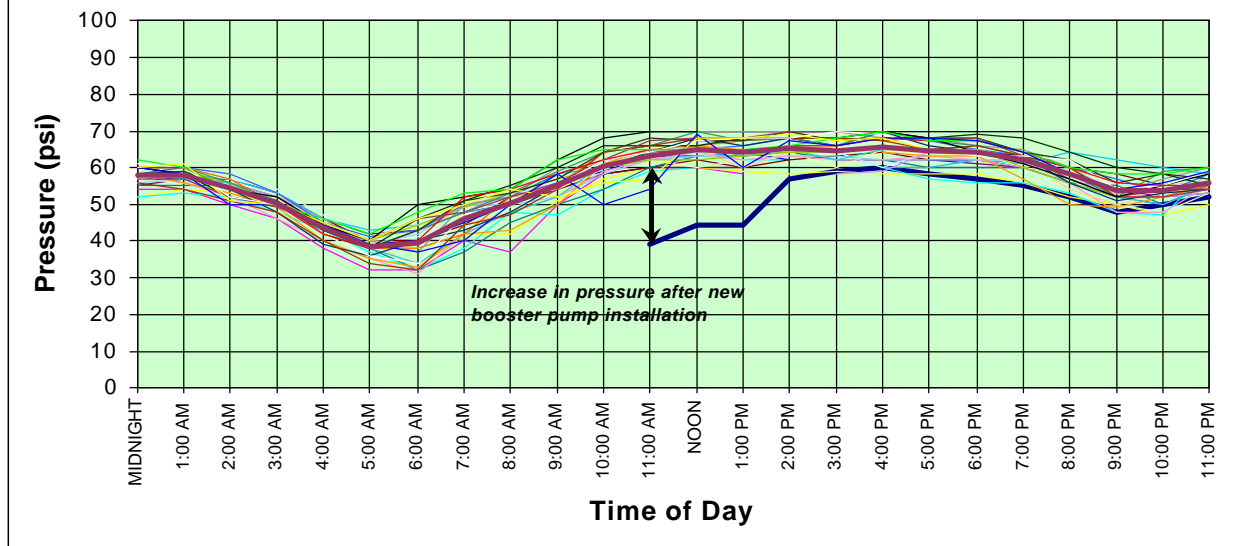
**Figure 16. Eagle Springs Pressure Recordings
7/10/00-8/14/00**

Figure 16 shows the results of pressure recordings at the Eagle Springs location from the period July 12 through August 15. Each line on the graph represents a different 24-hour period. The heavy blue line that begins near the lower middle part of the graph shows pressures measured prior to the new booster pump going online. Because the booster pump was put online so soon after pressure recording began, there were few pressure measurements taken to show pre-booster conditions. Nevertheless, the graph clearly shows the effect of the booster pump. Pressure recording began at approximately 11:00 a.m. on July 12. The new booster pump went online at approximately 2:00 p.m. on the same day. The booster pump increased pressure at the highest point in Eagle Springs by about 20 psi. The effect was evident within minutes.

Staff believes that the effect of the booster continues to be about a 20 psi increase over pressures that existed prior to installation of the new booster. Eagle Water has estimated that they believe the minimum water pressure at the highest point in Eagle Springs prior to the new booster going online (e.g., at 6 a.m. during the summer) was 45 to 48 psi. However, based on the pressures measured in Eagle Springs so far and the effect of the booster pump, Staff believes minimum pressures were much lower. Even now, with the new booster pump operating, pressures drop daily from 5 to 6 a.m. to the 40 psi range, and have been below 35 psi on a few occasions. Without the new booster, pressures would have been much lower.

With the new booster online, pressures do appear to meet DEQ minimum standards. Although pressures are low in the early morning hours, they are still almost always above 35 psi. During the afternoon and early evening hours, pressures are usually above 60 psi. It is important to note that the pressures indicated here, because they have been measured at nearly the highest point in Eagle Springs, are the lowest pressures to be experienced by any customer.

1. Staff recommends that Eagle Water continue to monitor pressures at both locations in the Bonita Hills and Eagle Springs subdivisions throughout the months of August and September.

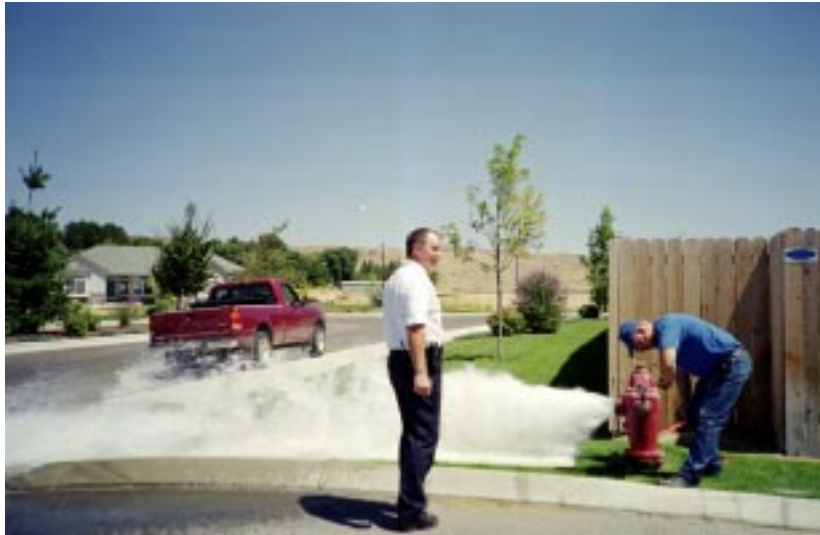
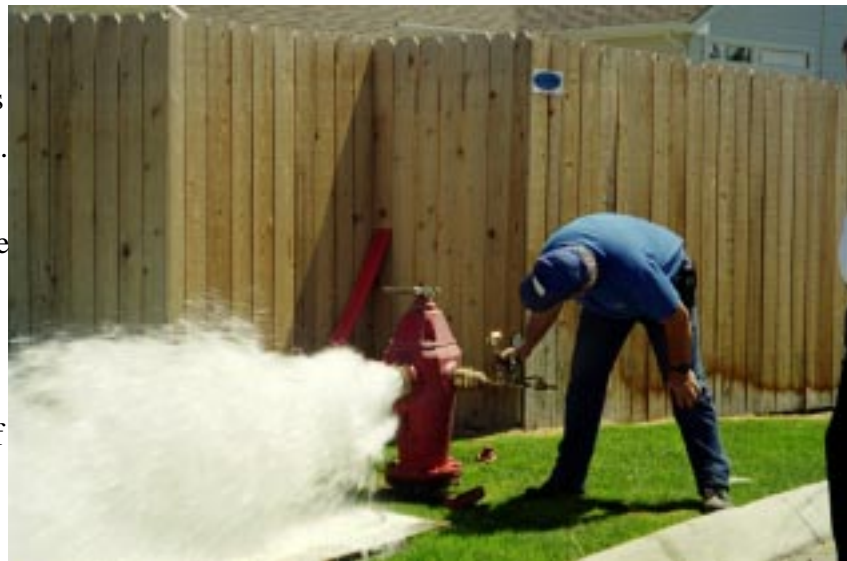
Figure 19. Norman Revels of Eagle Water Company and Kurt McClenny of the Eagle Fire District perform a fire flow test on a hydrant at the Eagle Springs Clubhouse on July 27, 2000.

The first test was conducted at a hydrant located on the lot where the Eagle Springs clubhouse and pool are located. Figures 19 and 20 show this test in progress. Because of the clubhouse at this location, the Eagle Fire District in accordance with the *Uniform Fire Code* requires that fire flows of at least 1500 gpm at 20 psi be available. The test was conducted at approximately 2:00 p.m. when pressures in the system were about 5 psi below

Figure 20. Norman Revels of Eagle Water Company check pressure during a fire flow test on July 27, 2000.

was conducted in the afternoon on any but the hottest days of the summer, it is probable that the required fire flow of 1500 gpm could be provided. The Eagle Fire District plans to conduct additional tests as new development progresses in Eagle Springs Phase 5.

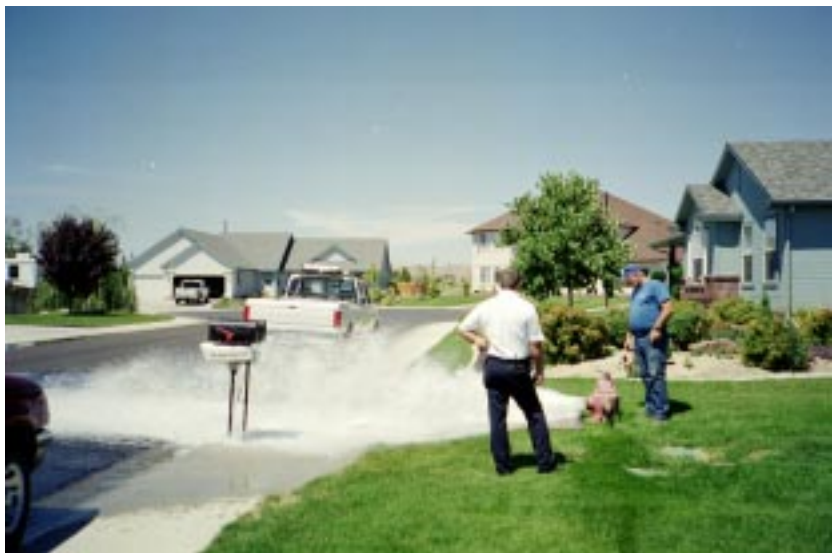
Figure 21. Fire flow test on July 27, 2000 at a hydrant located on N. Blacktail Place.

of the corner of W. Bucktail Drive and N. Blacktail Place. Figure 21 shows this test in progress. During this test, flow was measured as 1630 gpm at a static pressure of 62 psi and a residual pressure of 32 psi. At a residual pressure of 20 psi, it is estimated that a flow rate of 2000 gpm could be sustained. As indicated by the results of the test, Eagle Water is easily capable of meeting fire flow requirements at this location. The reason Eagle Water has greater capability to provide higher fire flows at this location than at the clubhouse is because of the difference in elevation between the two locations.
