INTERMOUNTAIN GAS COMPANY

Subject: Response to November 16, 2018 Notice of Probable Violations – Sawtooth District

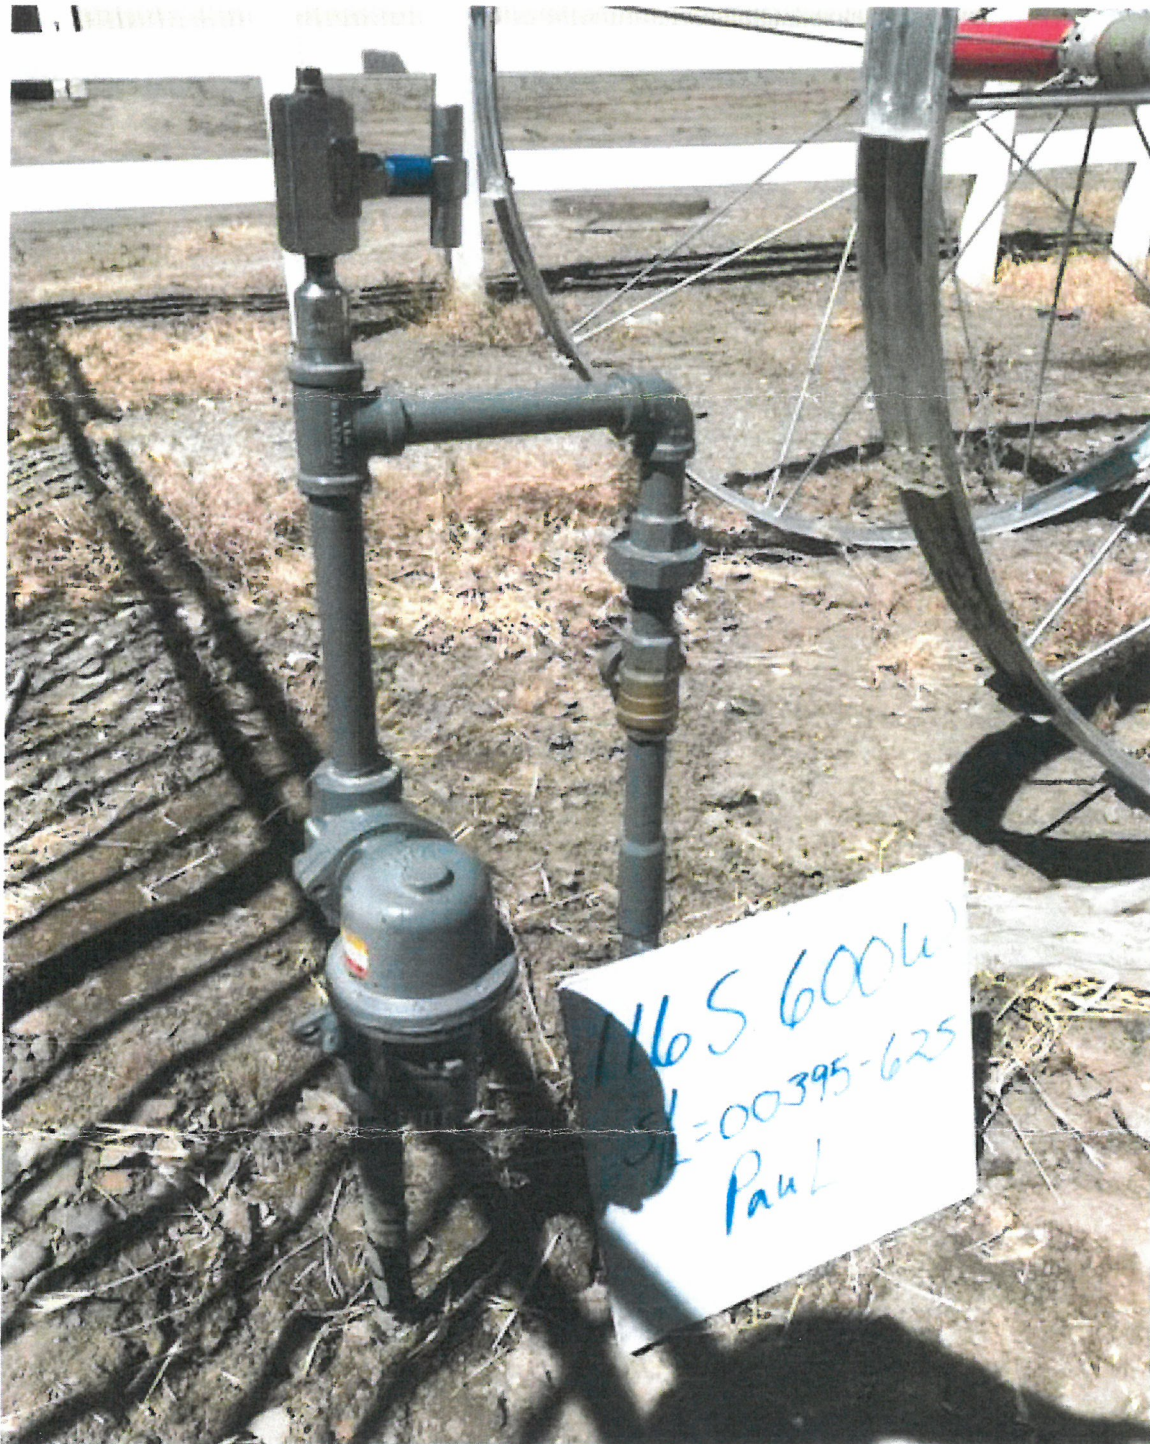
Figure 1: HPSS - 116 S, 600 W, Paul, ID

During your inspection it was noted that the High Pressure Service Set (HPSS) for service line 00395-625 located at 114 S 600 West in Paul, Idaho had corrosion issues beyond what is considered light surface oxide, as a result it had numerous leaks. A contributing cause of the leaks is the lack of a uniform protective coating sufficient to prevent atmospheric corrosion.

Intermountain Gas Company (IGC) acknowledges that the HPSS on service line 00395-625 had the presence of light surface oxide and leaks at some threaded connections. Within two weeks of receiving the May 14-16, 2018 Idaho PUC Pipeline Safety Inspection Summary findings, the Corrosion Technician investigated the HPSSs with reported shorts. Using trouble shooting methods, the Technician found the HPSS was not shorted to the corrugated metal pipe. On December 12, 2018, the Technician returned to take ultrasonic thickness (UT) readings of the pipe nipples included in the HPSS. All UT readings were within API 5L tolerances, thus indicating no wall loss due to corrosion. IGC affirms that since the pipe was being appropriately cathodically protected, we are promoting safe operation of the pipeline.

Additionally, no corrosion leaks were found. The leaks on the HPSS discovered during the IPUC inspection were repaired by greasing the inlet stop and tightening loose fittings. (See [Figure 1](#).) Lastly, IGC accelerated the HPPS Inspection schedule of this HPSS from 2019 to May 29, 2018. The inspection included painting the HPSS assembly, replacing the regulator and testing for lock-up.
