May 16, 2019

Subject: Response to April 8, 2019 Notice of Probable Violations – Owyhee District

This letter is intended to address the April 8, 2019 Notice of Probable Violations (NOPV) identified by the Idaho Public Utilities Commission (IPUC) during the January 17, 2019 follow-up High Pressure Service Set (HPSS) inspection of Intermountain Gas Company’s (IGC) equipment in the Owyhee District. Listed below are the stated probable violations and the respective corrective actions taken by IGC.

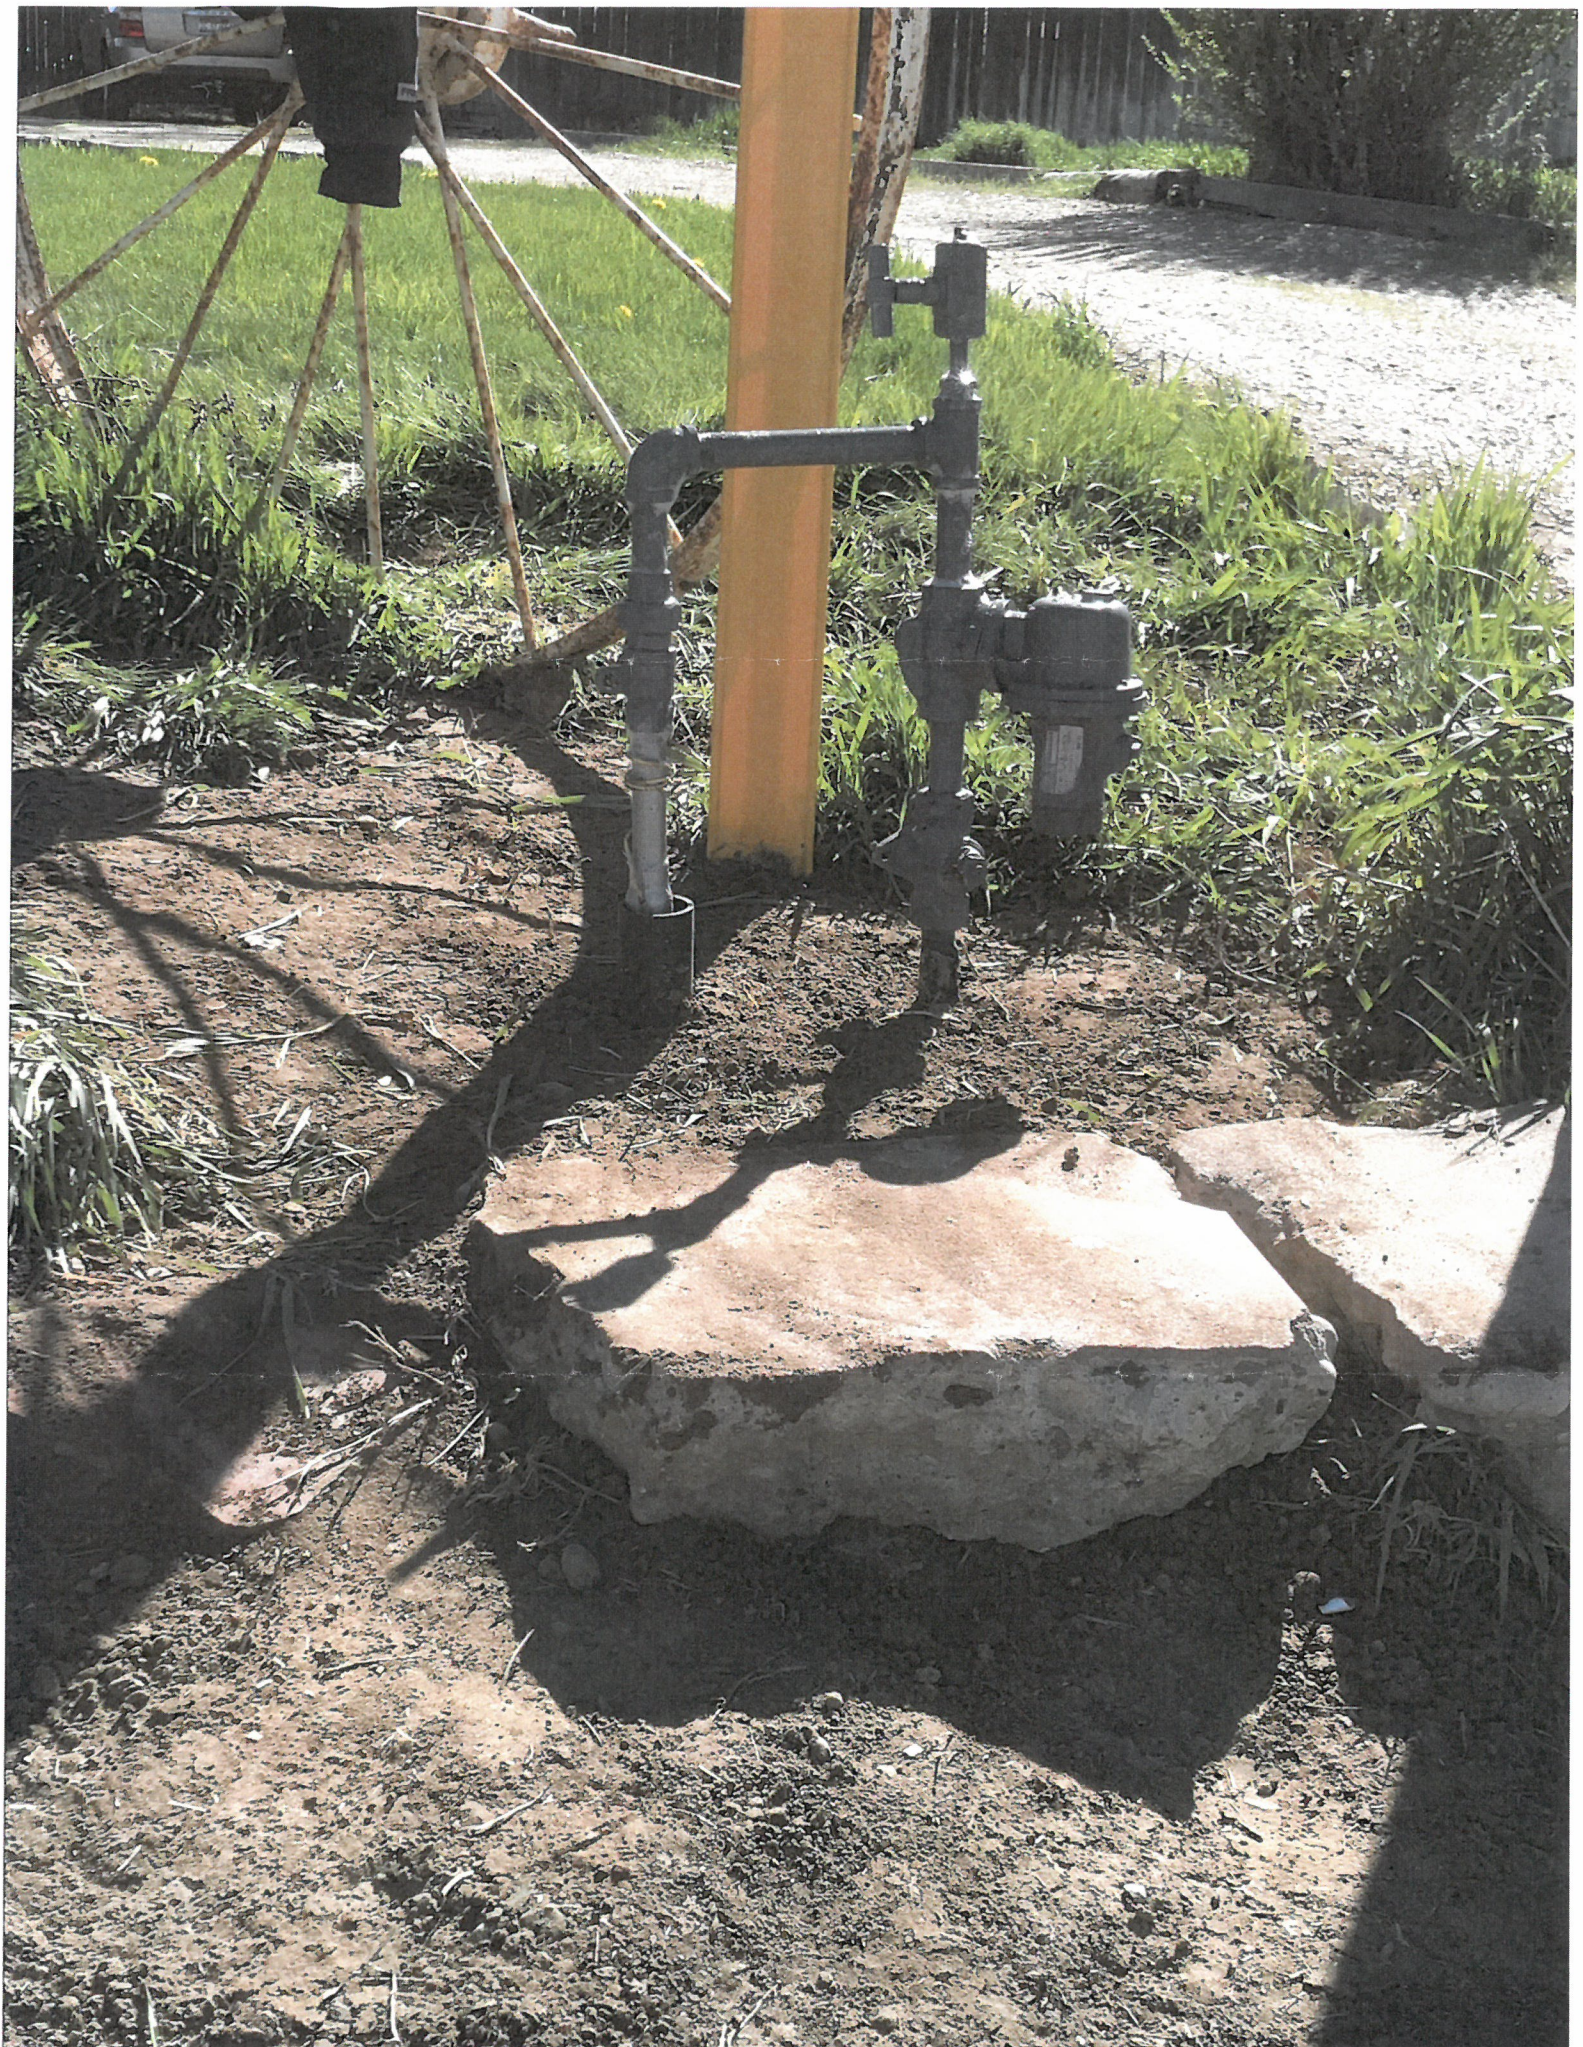
Intermountain Gas Company (IGC) acknowledges that the outlet anodeless service riser (ASR) of the HPSS associated with service line 07676-317 had localized pitting. IGC also acknowledges the outlet riser was not cleaned and painted during the HPSS Inspection performed on September 4, 2018. In response to the findings reported by Bruce Perkins via email on January 18, 2019, IGC re-inspected the HPSS on January 21, 2019 at which time the outlet ASR was cleaned and painted. IGC also re-wrapped the inlet riser due to some nicks found in the coating. After further investigation, IGC replaced the outlet riser on April 19, 2019. (See Exhibit 1)

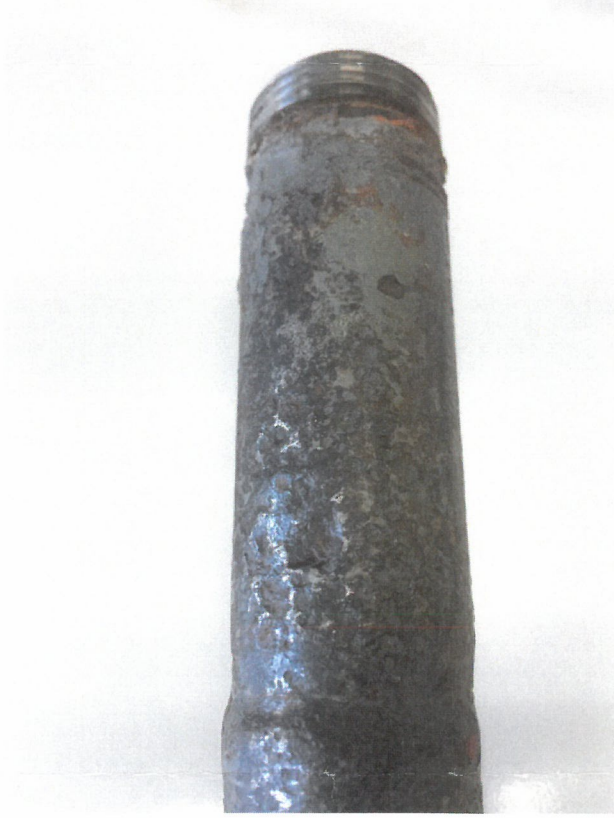
Description: An employee performing a High Pressure Service Set (HPSS) Inspection failed to notice pitting on an ASR. When pitting or corrosion is overlooked during inspection, proper mitigation and repair is not scheduled or performed. Pitting and/or corrosion can lead to a hazardous leak when not mitigated or repaired. This Compliance Message is intended to increase awareness of the potential for pitting and/or corrosion on ASRs.

Action Required: When performing Atmospheric Corrosion, Farm Tap or HPSS Inspections, always inspect ASRs. When performing mitigation or making repairs, always clean and recoat if pitting and/or evidence of Atmospheric Corrosion is found that exceeds a light oxide formation. When pitting or metal loss exceeds company wall thickness metal loss criteria (20% at CNG, 10% at IGC, 30% at MDU/GPNG) contact Engineering or replace the ASR.
