INTERMOUNTAIN GAS COMPANY

Subject: Response to Notice of Probable Violations dated June 19, 2020 (Report # 1202004)

This letter is intended to address three probable violations stemming from a field inspection of Intermountain Gas Company's (IGC) equipment in the Boise District conducted June 15-18, 2020. Specifically, we are addressing how we plan to bring the probable violations into full compliance.

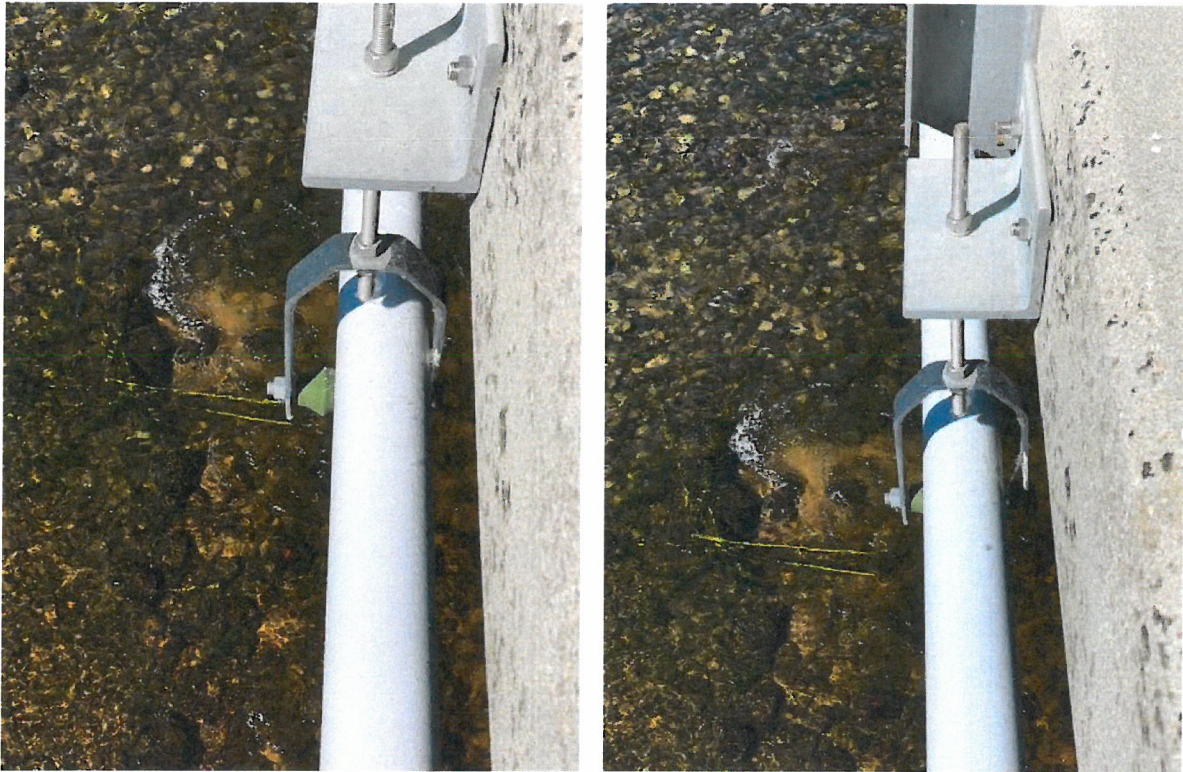
Figure 1

Pipelines installed through pipe hangers shall be centered in the hanger and the pipe must not come in contact with the bracket.

During the inspection it was noted that patrol PP425011 was off center and making contact with the bracket.

**PP425011 located at South Eckert
Road and the Boise River**

IGC acknowledges the findings brought forth by the IPUC stated above. The pipeline hanger at PP-425-011 located at South Eckert Road and the Boise River was adjusted on June 22, 2020. (See Figure 1.)
