INTERMOUNTAIN GAS COMPANY

Subject: Response to November 16, 2018 Notice of Probable Violations – Owyhee District

This letter is intended to address the November 16, 2018 Notice of Probable Violations identified by the Idaho Public Utilities Commission during the August 21-23, 2018 Nampa #2 Field Inspection of Intermountain Gas Company's (IGC) equipment in the Owyhee District.

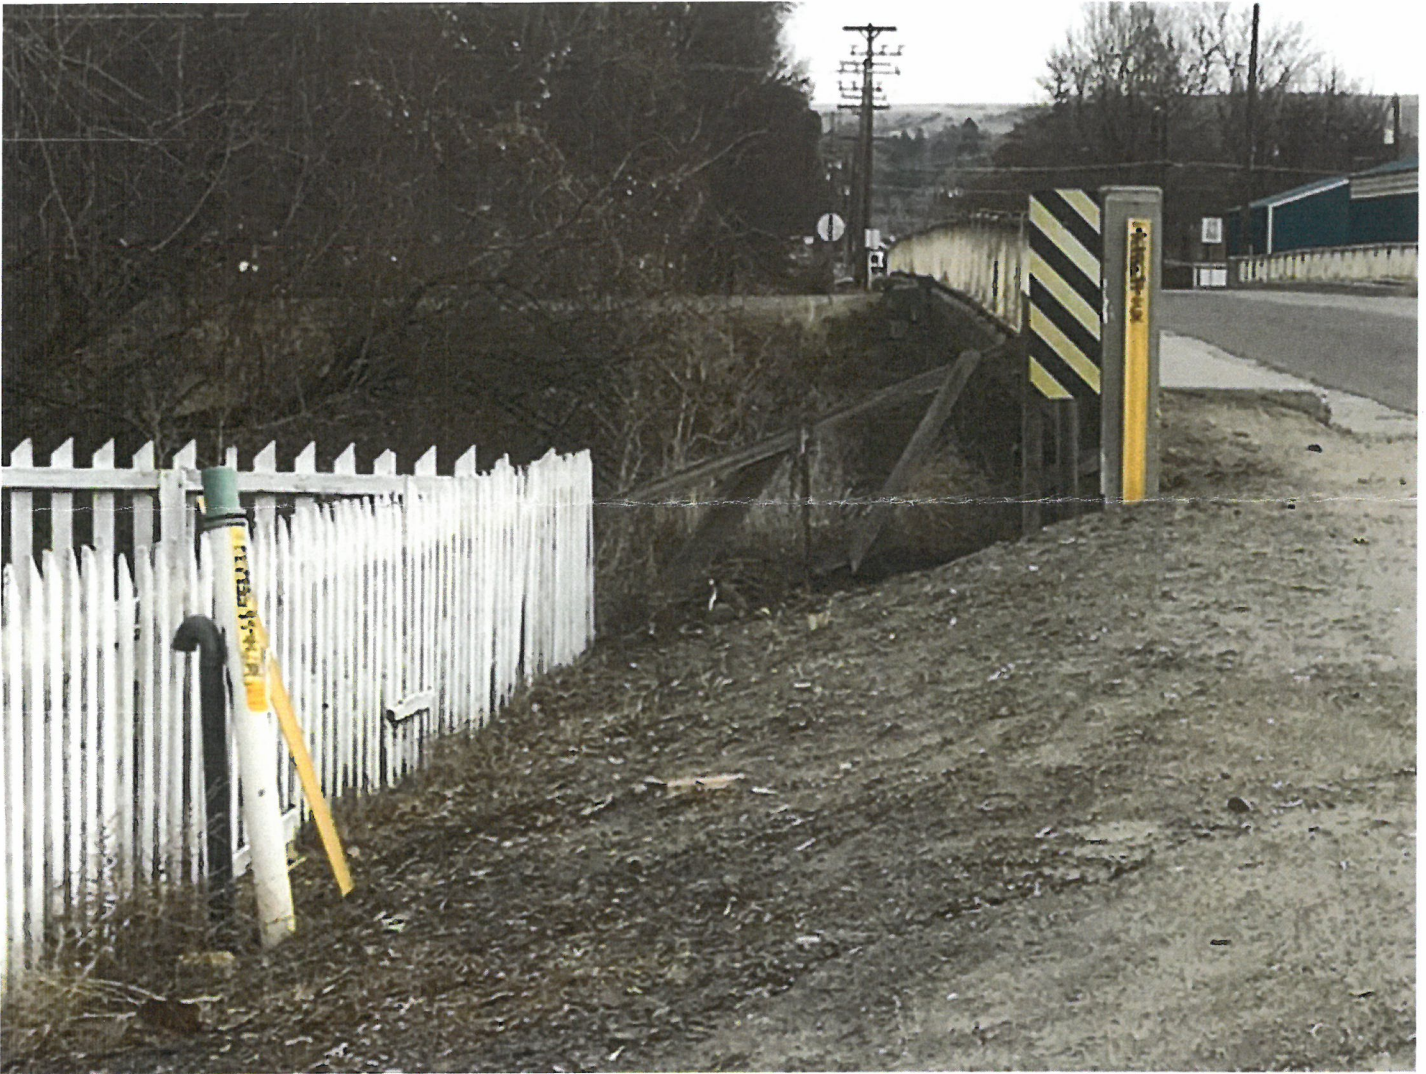
Figure 1: Vent Stack for Casing 26701315

During the inspection it was noted that one vent (#267-01-315) was completely buried and three others were within a few inches of being in the same condition. The concern is during inclement weather either snow would cover vent or water intrusion.

On August 31, 2018, IGC raised the vent stacks for casings 26701315, 26701306, 2671305, and 26701309. (See [Figure 1](#), [Figure 2](#), [Figure 3](#), [Figure 4](#), and [Figure 5](#) respectively.)

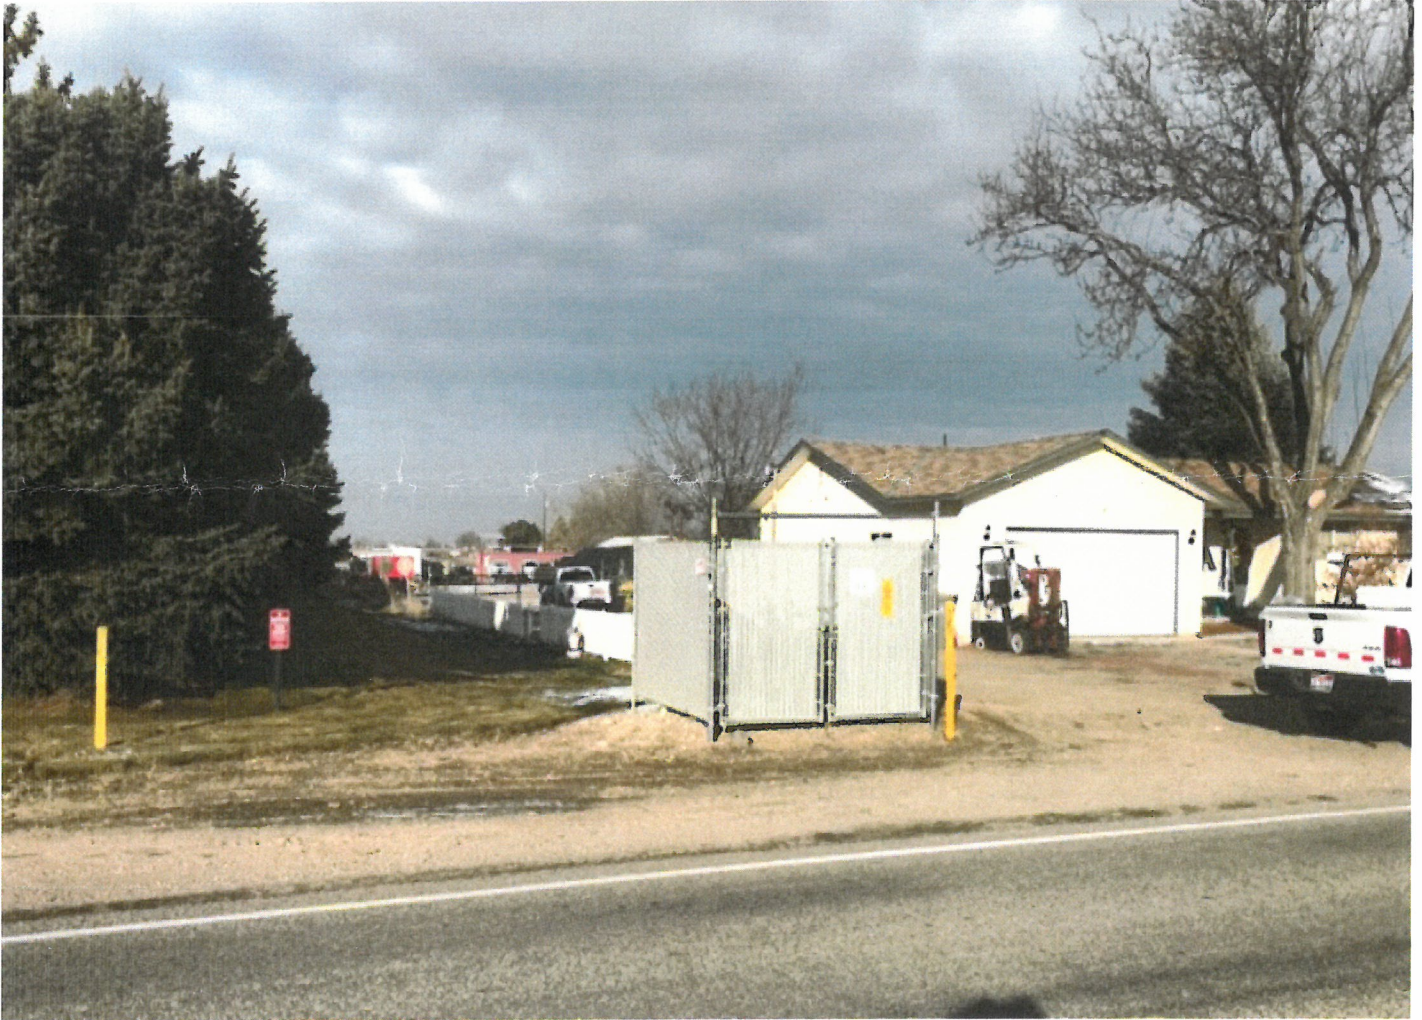
Figure 6: Line Markers at Regulator Station 40107

During the inspection it was noted that along Columbia driving to reg station 40107 there were no visual line markers. On one end a carsonite was found flat on the ground, but on the other end there were no markers.

IGC added Carsonite pipeline markers along Columbia Road near Regulator Station 40107 as requested. (See [Figure 6](#).)
