CASE NO. EAG-W-00-1

**STAFF INVESTIGATION OF
EAGLE WATER COMPANY
AND ITS ABILITY TO PROVIDE
ADEQUATE WATER SERVICE
TO THE CUSTOMERS OF
EAGLE SPRINGS ESTATES SUBDIVISION
AND ADJACENT CERTIFICATED AREAS**

**Report of the
Idaho Public Utilities Commission Staff**

August 22, 2000

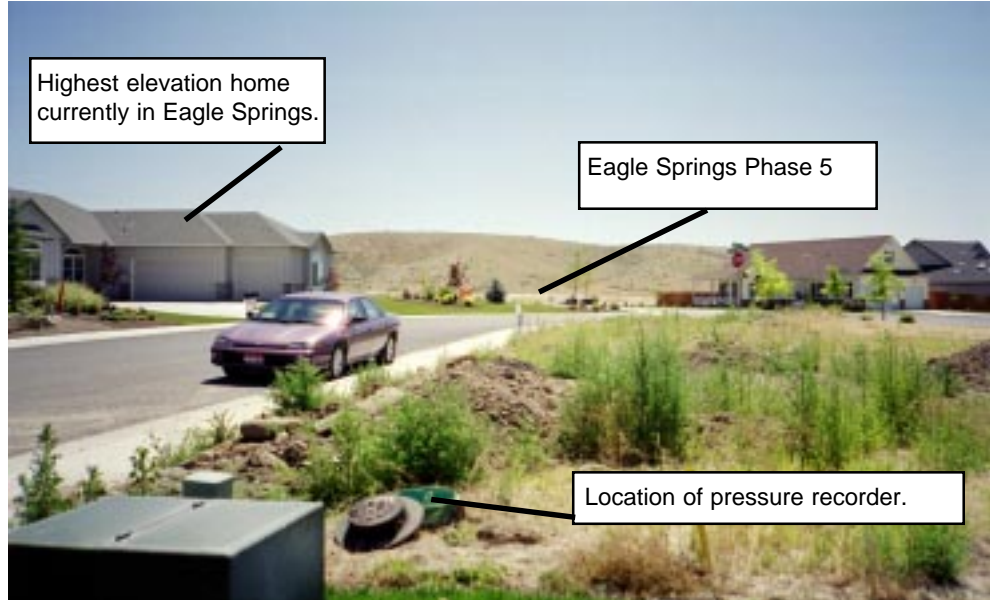
Figure 13. Location of continuous pressure recorder in relation to the highest elevation customer and to Phase 5 of Eagle Springs Estates.

One recorder was placed on a vacant lot in Eagle Springs near the corner of W. Big Springs Blvd. and N. Halter Way. Figure 13 shows a photo of the location of this recorder. Figure 14 is a closer view of this pressure recorder.

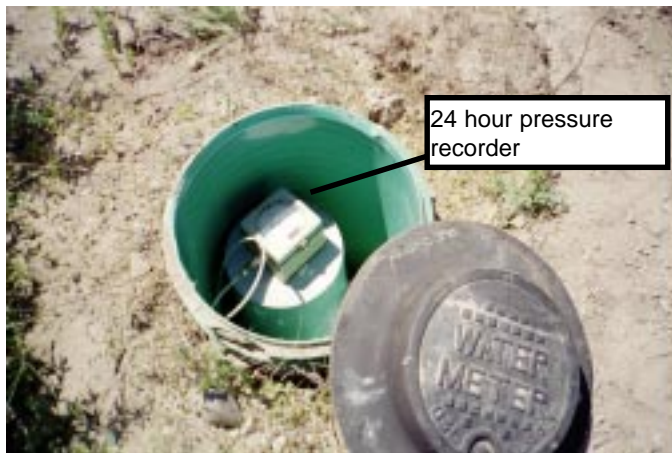
Figure 14. 24-hour continuous pressure recorder installed in meter box.

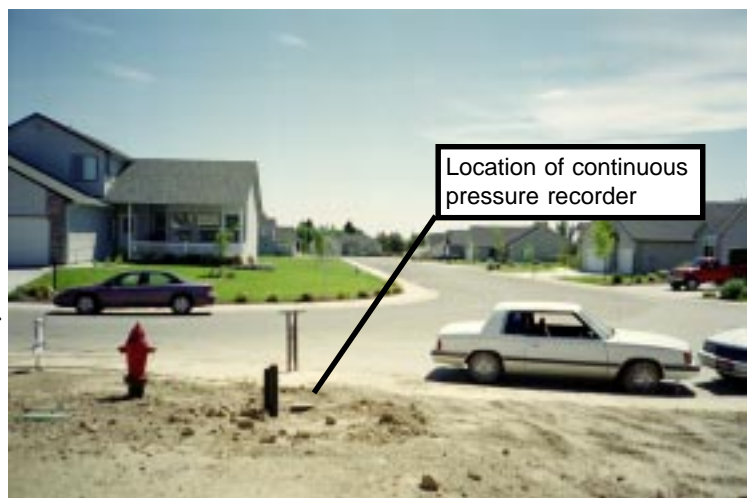
Several days later, another pressure recorder was placed on a vacant lot in Bonita Hills near the corner of N. Blacktail Ave. and W. Shadow Rock Street. The recorders continuously measure water pressure and record it with pen and ink on a 24-hour circular paper chart. Charts are changed daily by Eagle Water.

Figure 15. Location of continuous pressure recorder in the Bonita Hills subdivision.

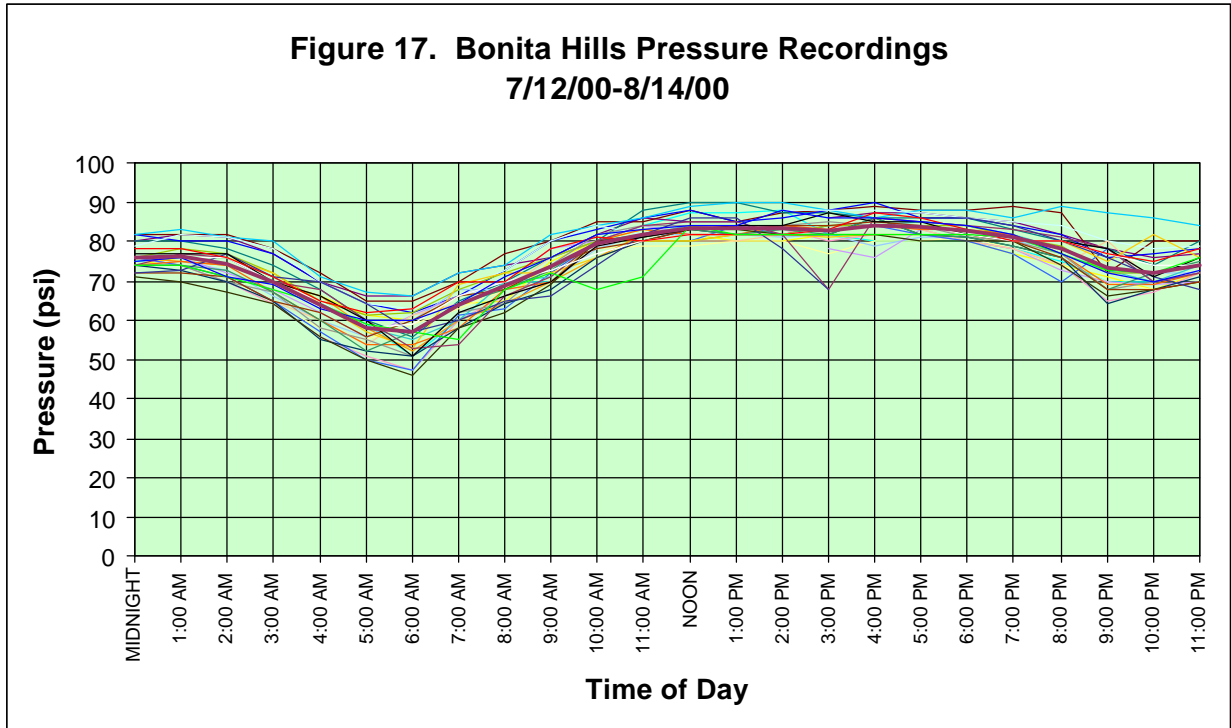
Pressure measurements have also been taken in Bonita Hills beginning July 12. Because this pressure recorder is located at close to the lowest point in the subdivision, it represents the highest water pressures to be expected for any customer. The results of these measurements are shown in Figure 17. As indicated by the graph, DEQ minimum standards are easily being met at this location.

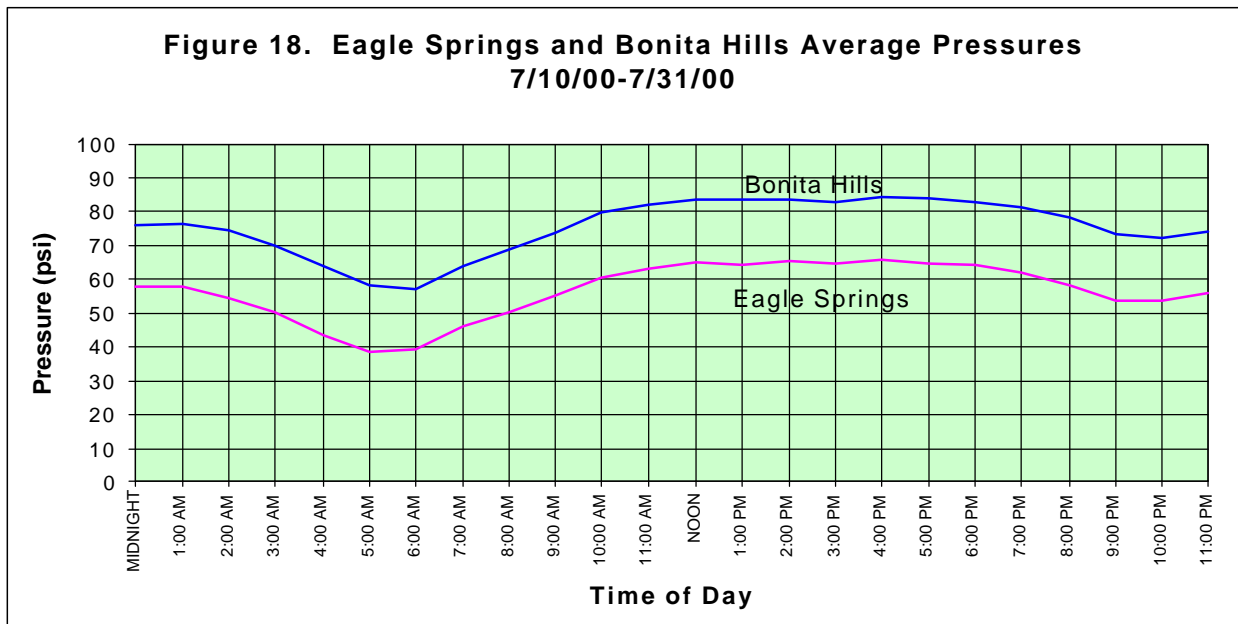
Figure 18 shows average pressures at both locations. Pressures at the Eagle Springs location follow a nearly identical pattern as those at Bonita Hills, but are generally about 20 psi lower.

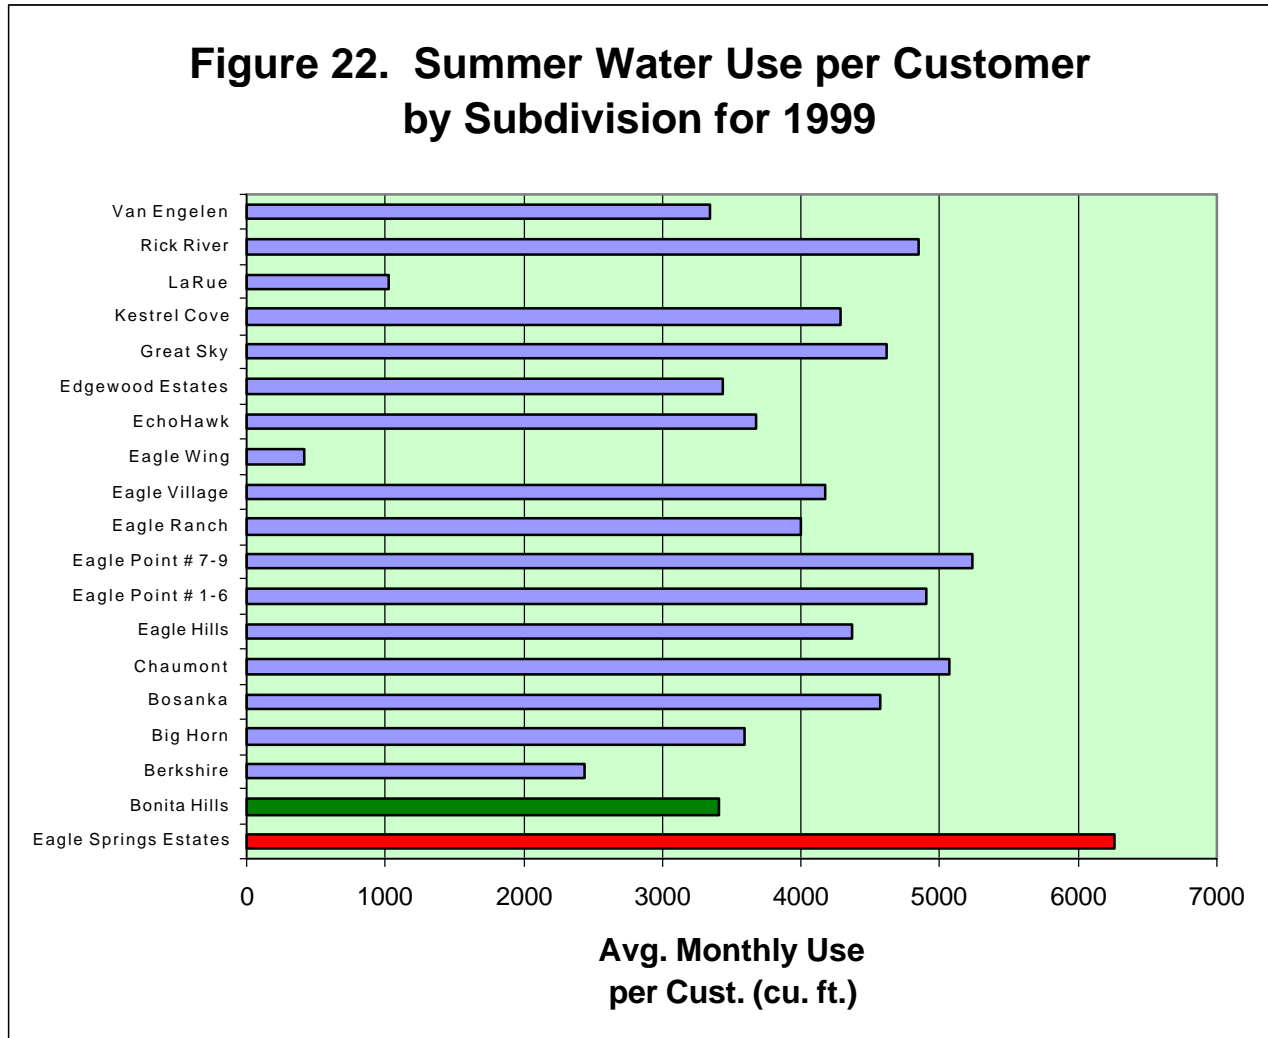
Staff gathered water usage data for customers in numerous subdivisions served by Eagle Water to try to make at least a rough comparison between the water usage of customers in Eagle Springs and Bonita Hills and customers in other subdivisions. Figure 22 shows the summer water usage per customer for the subdivisions examined. As shown by the Figure, customers in Eagle Springs Estates used more water than customers in any other subdivision. Customer usage in Bonita Hills was much closer to average.

Staff cautions against drawing too many conclusions from this comparison. It should be pointed out that Eagle Springs Estates is still a developing subdivision. Many residents are still establishing new lawns; consequently, they are likely to use more water. In addition, lot sizes vary between subdivisions and soil types may be considerably different.

Staff is uncertain whether the higher per customer consumption in Eagle Springs will continue, but believes it may eventually moderate somewhat. Nevertheless, the current higher consumption rate by Eagle Springs customers exacerbates low pressure problems.
